# Good Practice Guide to

# Maintain Motor Efficiency

Based on the 2019 and 2003 Rewind Studies  
of premium efficiency, energy efficient,  
IE2 (formerlyEF1) and IE3 motors

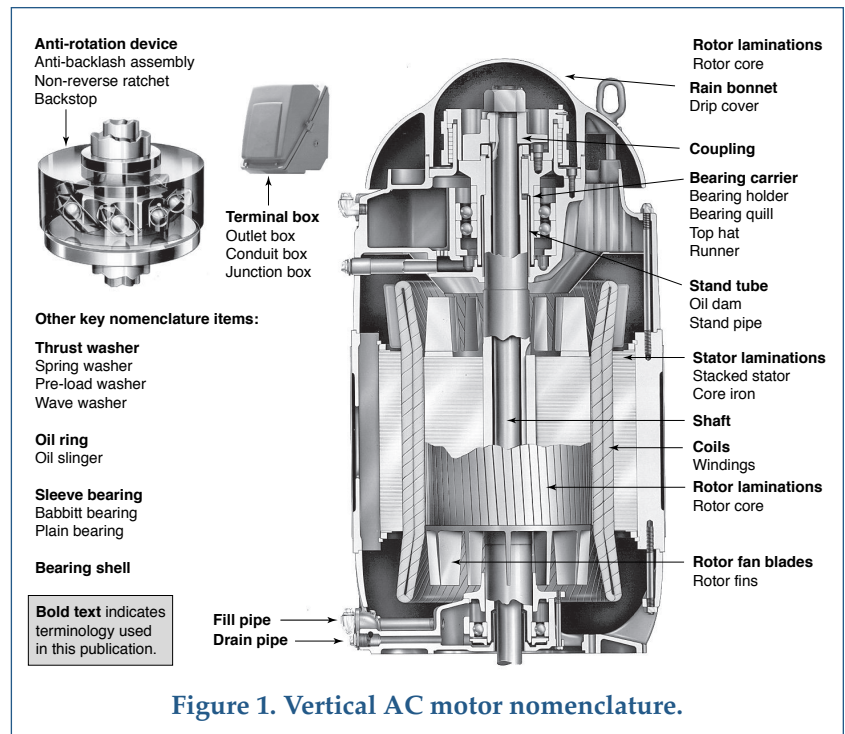
Figure 1. Vertical AC motor nomenclature.

The terms used to describe horizontal and vertical induction motors in this guide are those commonly found in other EASA, AEMT, NEMA, IEC, IEEE, and ANSI documents. These terms are printed in bold type in Figure 1 and Figure 2 (Page 2), with alternate terms listed beneath them.

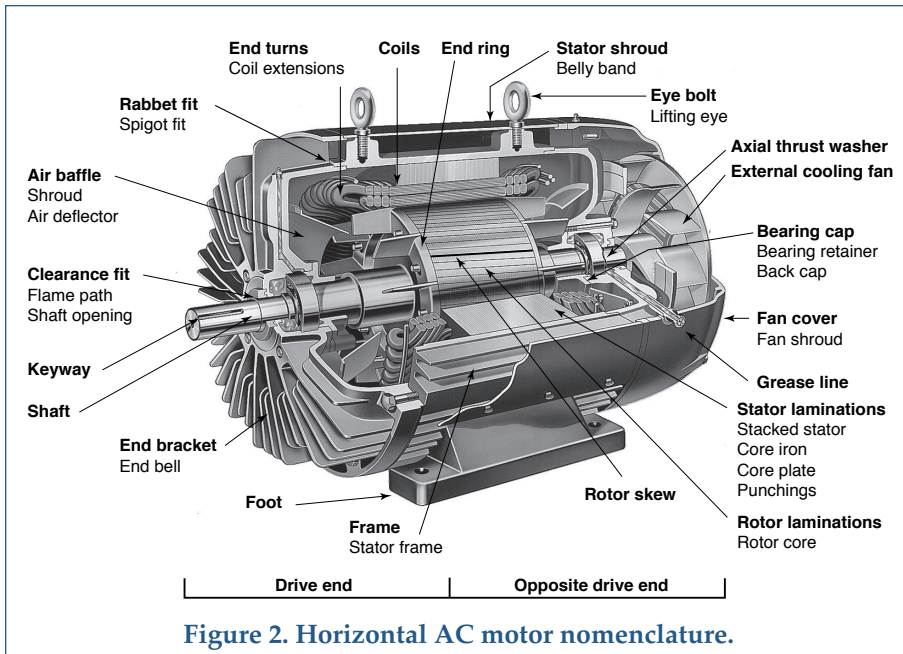
Figure 2. Horizontal AC motor nomenclature.

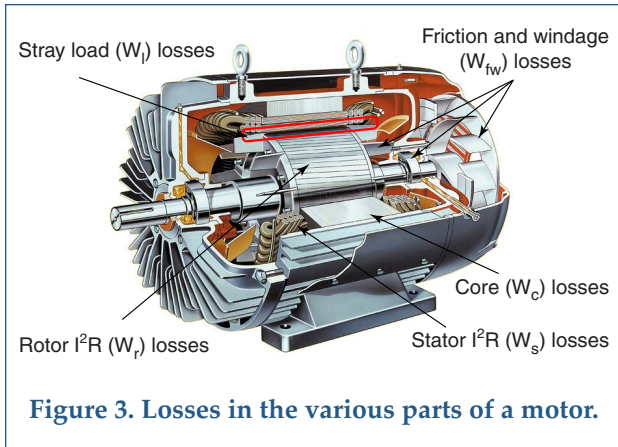
Figure 3. Losses in the various parts of a motor.

There are five types of losses in an induction motor (see Figure 3, Page 2):

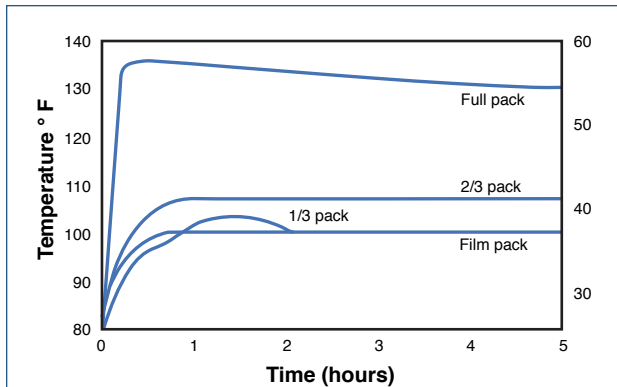
Figure 8. Short-term “break in” periods may not be adequate to reduce bearing losses, regardless of fill, as illustrated here. (From *Lubrication Fundamentals*, 1st ed. by Mobil Oil Corp.)

**Impact of too much bearing grease.** Several studies have found that over-greasing the bearings can increase friction losses (see Figure 6 and Figure 7 on Page 6 and Figure 8). For the 2003 rewind study, grease was added to the bearings of two rewind test units in Group A. No change in lubrication was made on the rest of the motors in the test. As expected, bearing friction on the over-greased motors increased and efficiency dropped 0.3 to 0.5%. Figure 9 illustrates the decrease in losses over time for one of the 60 hp (45 kW) motors in the 2003 rewind study.

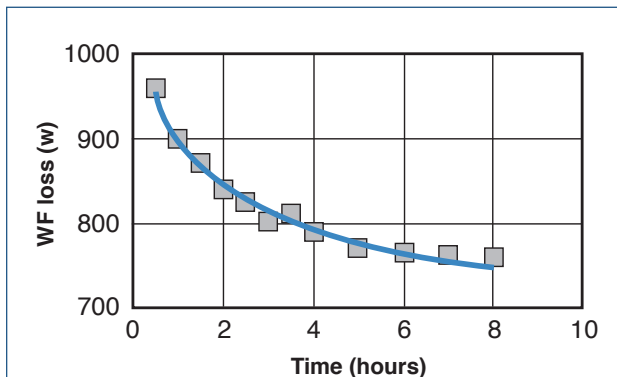
Figure 9. Reduction in F & W losses during the break-in run for a 60 hp (45 kW) motor with proper grease fill tested in the 2003 rewind study.

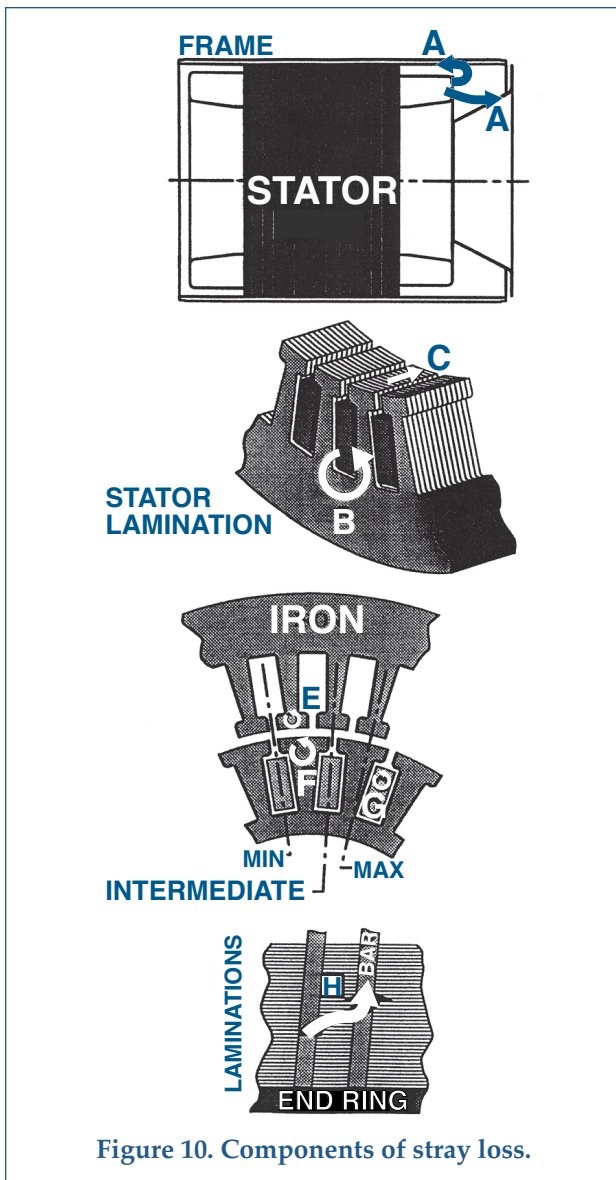
Figure 10. Components of stray loss.

**Stray loss analysis.** The stray load losses for the motors in Group A of the 2003 rewind study increased significantly. The cause was the mechanical damage done to the stator core (i.e., splayed ends of lamination teeth) in removing the old windings and slot insulation. This in turn increased the pulsating or zigzag losses (see Figure 10, Page 8).

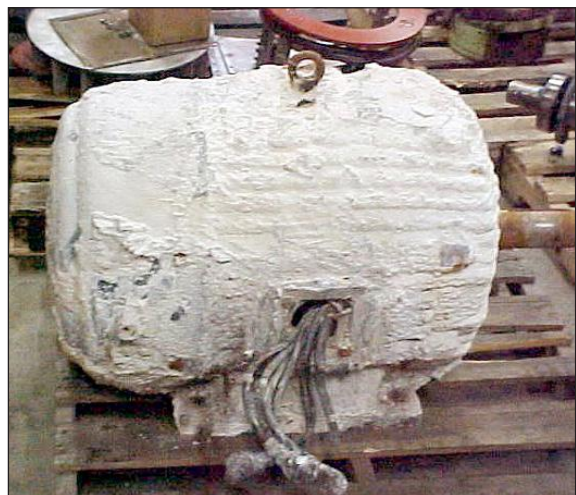
Figure 15. Motor with blocked cooling fins.

- General condition—old/new, dirty/clean, etc.
- Cooling air ducts clear/obstructed—may have caused overheating (see Figure 15).
- Shaft discoloured (brown/blue)—sign of rotor overheating or bearing seizure.
- Parts missing, damaged or previously replaced/repaired—e.g., seals, stator cooling ribs, fan, fan cover, terminal box, etc.

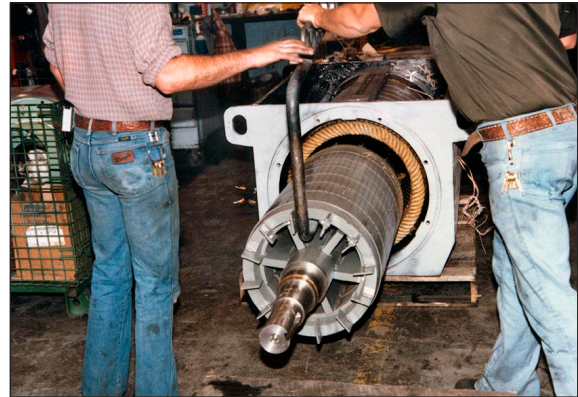
Figure 17. Rotor removal using a rotor removal tool.

The rotor presents a considerable overhung load when one end bracket has been removed. Allowing it to scrape along the stator bore during rotor removal can damage the air gap surfaces of both stator and rotor and increase losses. Winding damage can also result. An effective way to remove and replace rotors in horizontal motors is by using a rotor removal tool (see Figure 17).

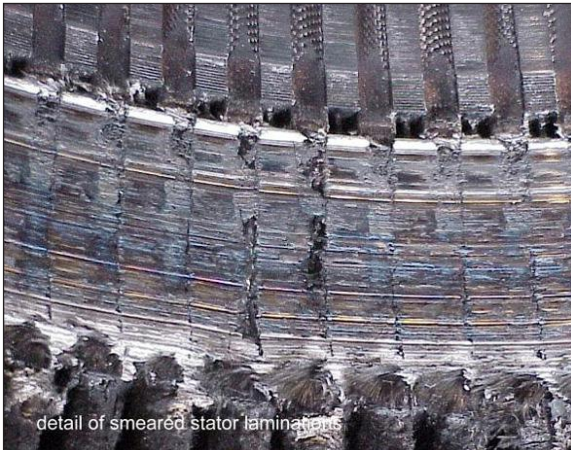
**Figure 18. Major mechanical damage to the stator bore; not repairable unless the core is restacked or replaced.**

- **Core rub**, often due to failure of one of the motor bearings or rotor pullover caused by excessive radial load. This smears the air gap surfaces of the laminations together and can increase eddy current loss. Depending upon the extent of the damage, the motor may not be repairable.
- **Major mechanical damage** to either the stator or rotor core. Pieces missing or fused together may sometimes be caused by a major electrical fault, such as a short circuit inside the slots. Any application with an ungrounded system or poor ground fault protection is particularly prone to this type of damage. If such damage has occurred, weigh its effect on motor efficiency and performance when considering a repair (see Figure 18).

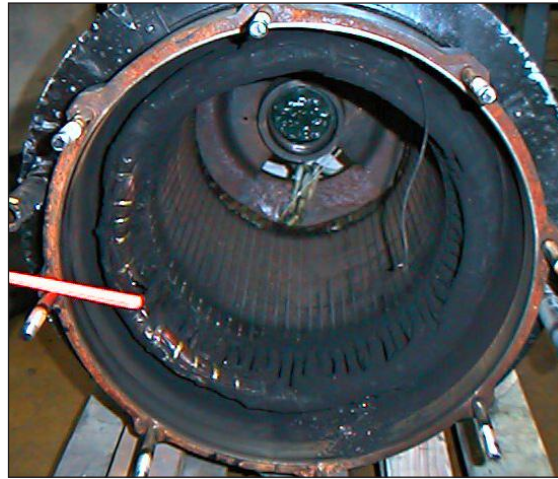
**Figure 19. Overall discolouration of the stator winding—usually indicates excessive temperature. Check load, power supply and cooling.**

**Serious overheating of the stator or rotor cores.** If the interlaminar insulation is damaged, eddy currents will increase, causing excessive iron losses (see Figure 19).

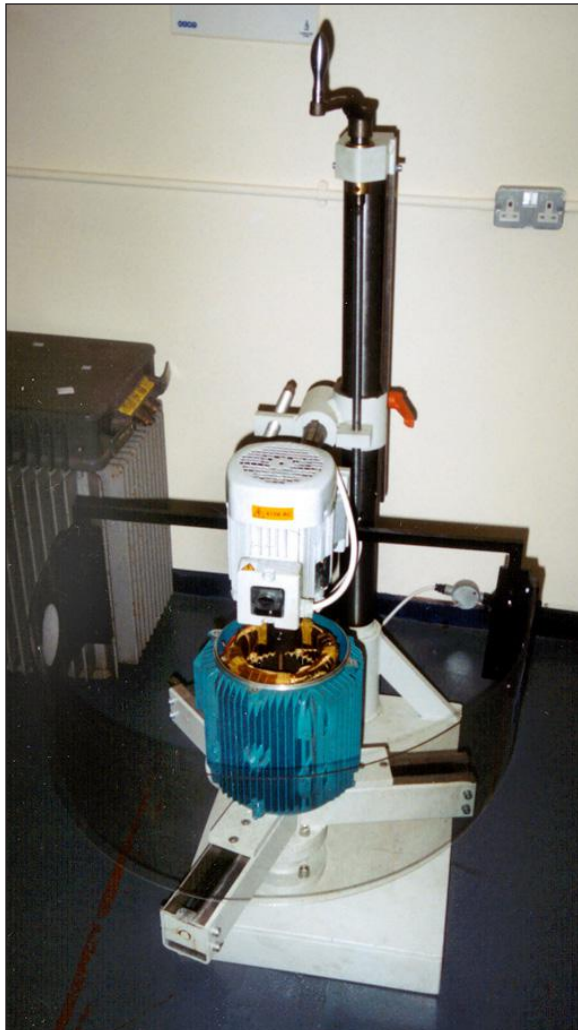
**Figure 20. Winding cut off machine.**

Cut off the coil extension of the winding as close to the stator core as possible without damaging the stator core. Cutoff machines are available commercially for this purpose (see Figure 20, Page 17). Regardless of the method used to cut off the coil extension, be careful not to damage the laminations.

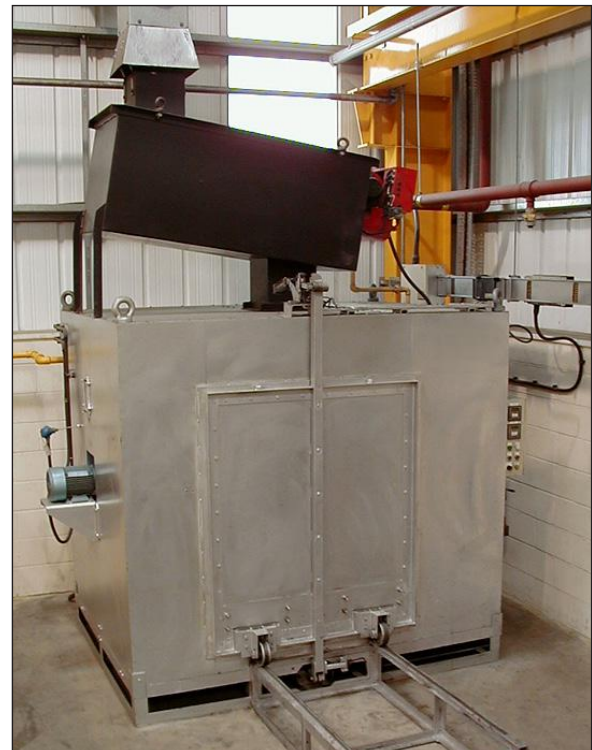
**Figure 21. Controlled temperature burnout oven.**

A distinct advantage of this method is that it provides a tightly controlled burnout process. Properly done, it ensures that the stator core will not reach a temperature that could damage the interlaminar insulation. It is important to set the oven temperature to monitor the temperature of the stator core, and to follow the oven manufacturer's instructions regarding cleaning and safety (see Figure 21).

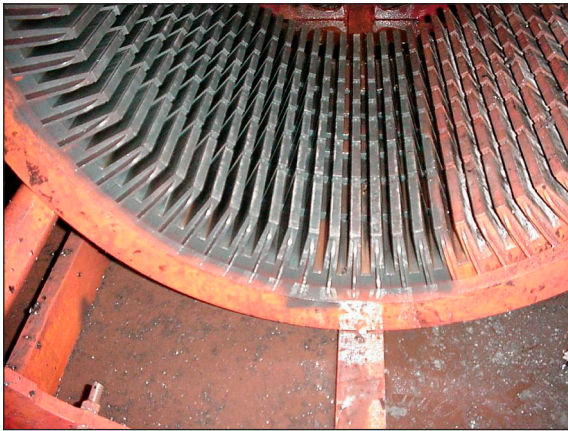
**Figure 22.** This core has been partially cleaned by using a high-pressure washer to remove the slot insulation debris.

- **Careful scraping** using a sharp knife to separate the remaining pieces of slot liner material from the core.
- **High-pressure washing** using a commercial/domestic high-pressure washer after which the core must be baked dry (see Figure 22, Page 19).
- **Abrasive blasting** using mildly abrasive material such as walnut hulls, crushed corncobs or plastic beads. Blasting with more abrasive materials like sand, crushed flint, ceramic pellets or even glass beads may cause surface shorting of the laminations, which increases core and stray losses.
- **Wire brushing** using a medium/soft wire brush.

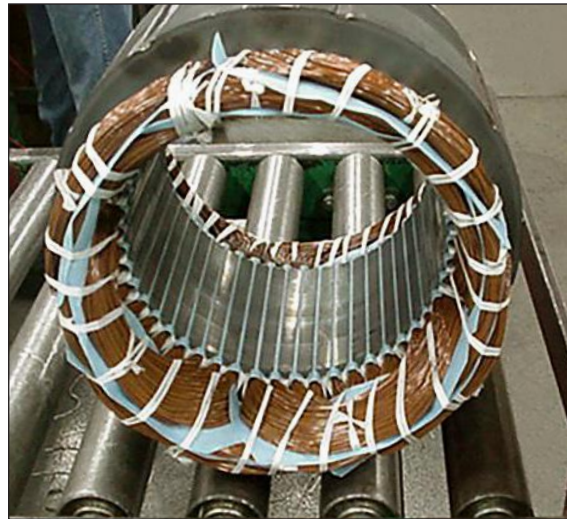
Figure 23. Typical concentric winding.

When production volume justifies the cost, motor manufacturers use automatic coil winding and inserting machinery to produce motors with concentric coil groups (see Figure 23). Repairers often find lap windings much quicker and easier to install (see Figure 24). This section therefore sets out the basic rules (in terms of maintaining efficiency) for just two types of rewind:

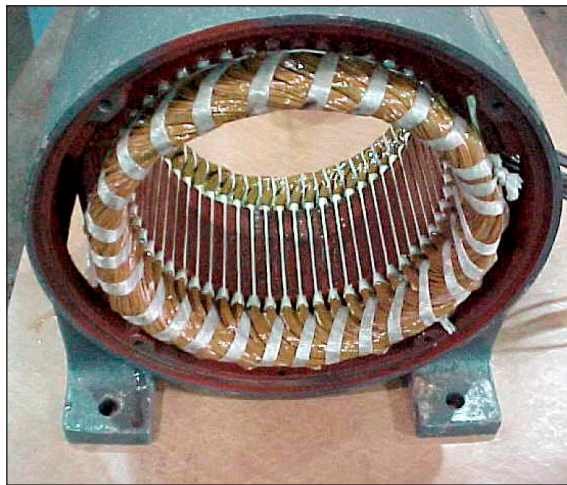
Figure 24. Typical lap winding.

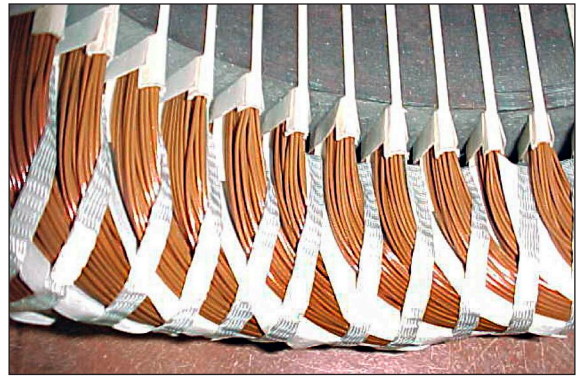
Figure 25. Typical coil extension for a 4-pole motor.

- Keep the coil extensions (see Figure 25) within the measured dimensions of the original winding.
- Do not extend the slot cell beyond the slot ends any more than is necessary to prevent strain on the slot cell.
- Do not extend the straight portions of the coil sides any farther than is necessary to clear the slot insulation.

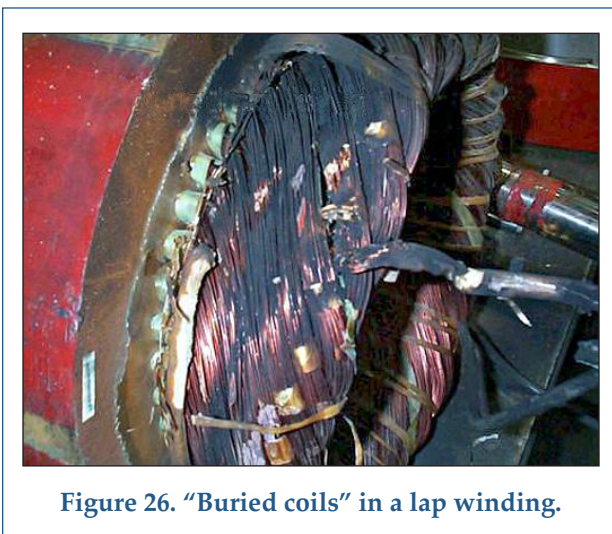
Figure 26. “Buried coils” in a lap winding.

When comparing lap and concentric windings, also consider the exposure of each coil to the air stream that cools the windings. Each coil of a lap winding has the same exposure to airflow, unlike the layers of a concentric winding that vary in their ability to dissipate heat. Avoid “buried coils” (see Figure 26), which tend to shorten insulation life and sometimes prevent good varnish impregnation. These drawbacks can apply to the middle layer of a 3-tier concentric winding. When copy-winding a 3-tier concentric winding, inserting the coils in the same manner as a lap winding balances the cooling effectiveness.

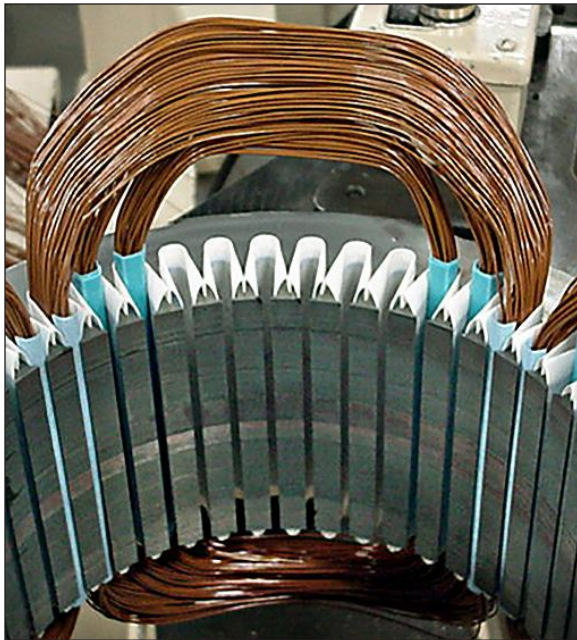
**Figure 27. Typical concentric coil group. Note that each coil has a different span.**

When production volume and economics justify it, manufacturers prefer using concentric windings (Figure 27), which can be machine-wound and require less labor. This benefits purchasers by keeping the cost of new motors economical. The drawback is that the turns in each coil of a concentric winding are not equally effective.

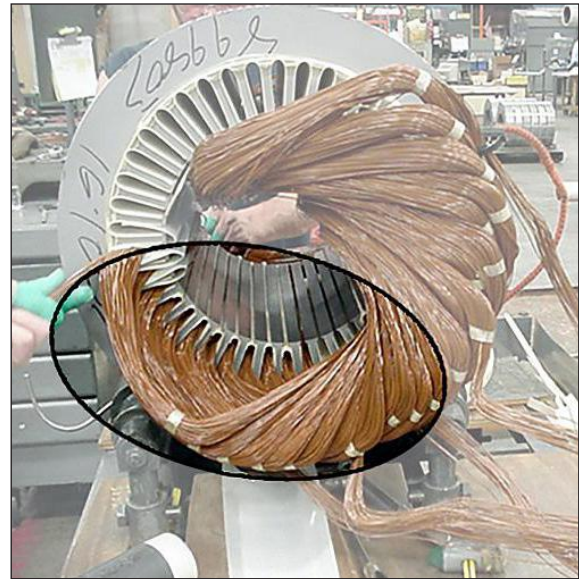
**Figure 28. Lap winding showing all coils with the same span.**

Service centres that use predominantly hand-winding methods normally find it easier to use lap windings because the coils are all the same (see Figure 28). (It takes a winder only slightly longer to manually insert a lap winding than a 2-layer concentric winding, and about the same insertion time as a 3-layer concentric.)

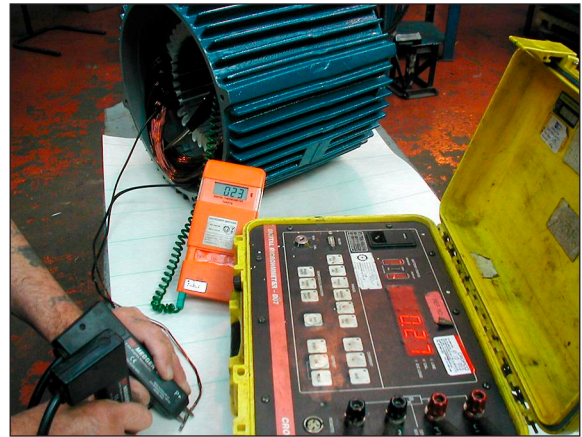
Figure 29. Measuring the resistance of a coil group. Note the meter leads are clamped securely to bare conductors; also note the ambient temperature thermometer.

The resistance of each phase or between leads should be within 2% of the average for random lap windings and may be higher for concentric windings (see Figure 29). A high resistance between leads could indicate a high-resistance connection joint. An open stator test in conjunction with thermography should reveal the faulty connection.

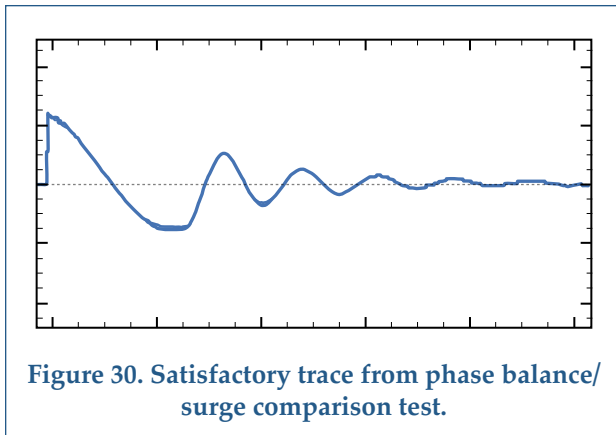
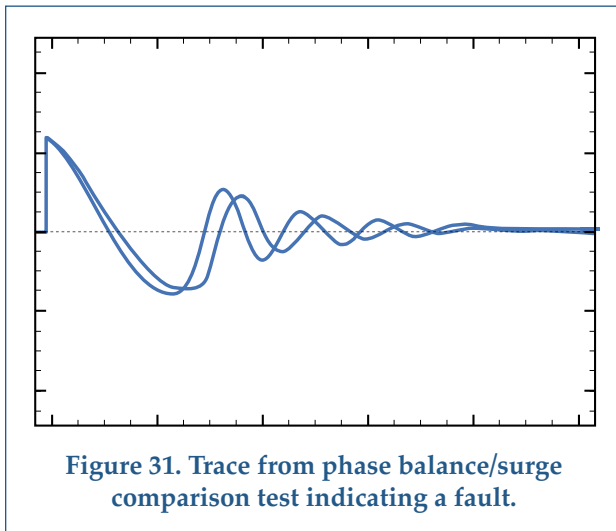
- The trace pattern indicates the phases are identical (okay—identical traces) or different (fault—traces do not match).
- The trace pattern gives guidance to type of fault (see equipment manufacturer’s guide).

Perform this test after the rewind but before varnish impregnation. The test ensures that all three phases are wound and connected in the same way. The test works by applying identical voltage pulses simultaneously to 2 phases of the winding, or sequentially for all 3 phases, and recording the voltage decay on an oscilloscope. Identical traces for each phase indicate that the decay curves for all phases are the same and that the phases are thus identical. Two traces that do not appear identical indicate a fault that must be found by inspection (see Figure 30 and Figure 31 on Page 26).
